GENERAL T.I. BULLETIN INDEX

Number	Gn001
(JCB Gen 003)	
Issue	1
Date	March 1990

SUBJECT: Tappet Adjustment

PRODUCTS AFFECTED: All Perkins 1000 series Engines

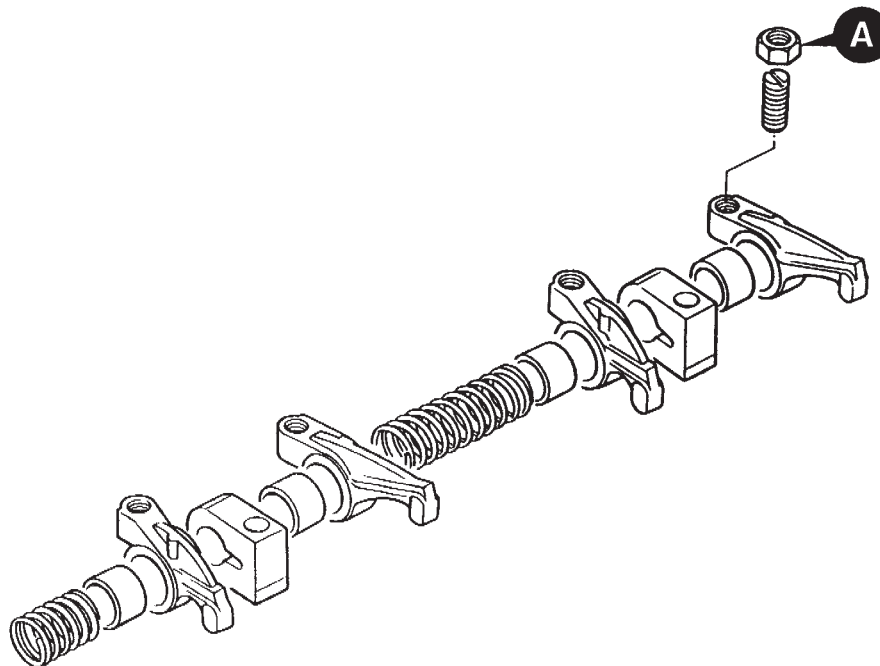
When tappet adjustment is required, it is important to re-torque the adjusting screw lock nut **A**. If this is not correctly actioned the adjusting screw will become loose which could cause damage to the tappet assembly and push rod.

Lock Nut Torque - 20 lbs ft.

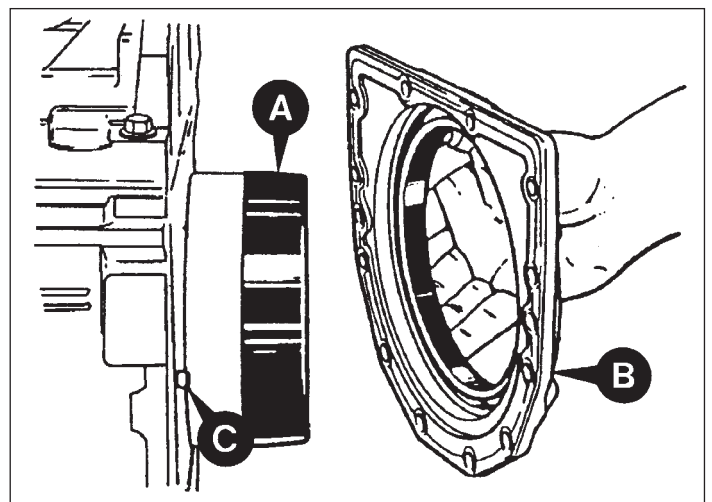
A number of reports by Perkins have been received concerning crankshaft rear main oil seal leaks. Little or no detail is completed in the comments section of the warranty claim form. Information given in the comments section will enable Perkins to identify the exact fault and take the correct remedial action.

If oil is leaking past the rear seal, oil will normally be found inside the flywheel housing with some evidence of leakage from the low inspection plate.

- 1 Remove the transmission.
- 2 Remove the flywheel using guide studs (remove two diametrically opposite bolts and temporarily fit guide studs).
- 3 Remove seal housing **B** setscrews. Using an appropriate lever gently pry the seal housing away from cylinder block, taking care not to damage the housing.
- 4 Press out old seal and fit replacement, using tool number PD.145D (see Perkins Service Manual), this will pre-set the seal depth as required.

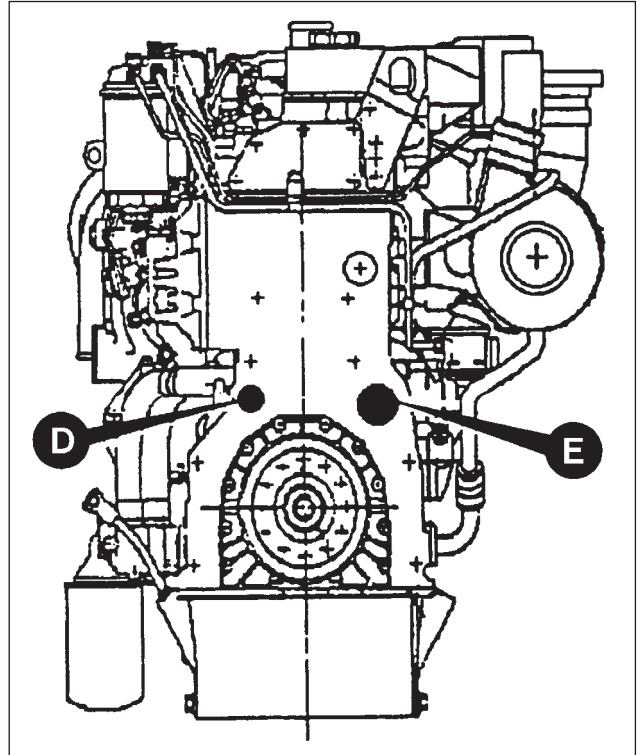
A leak from this area can usually be identified by a trace of oil along the contact face of block and flywheel housing on the fuel pump side of the engine.

- 1.1 Remove the transmission.
- 1.2 Remove the flywheel using guide studs (remove two diametrically opposite bolts and temporarily fit guide studs).
- 1.3 Remove the starter motor.
- 1.4 Remove the flywheel housing (it may be necessary to tap the housing using a soft hammer to disengage the housing dowels).
- 1.5 Remove the threaded gallery plug **D** located top left of cylinder block using appropriate allen key.
- 1.6 Fit a new plug/washer using Loctite 574 Multigasket and torque to 85 Nm (62.5 lbf ft).
- 1.7 Refit flywheel housing and torque securing screws M10 to 44 Nm (33 lbf ft) and M12 to 75 Nm (55 lbf ft).
- 1.8 Refit flywheel using guide studs and torque retaining bolts to 105 Nm (77 lbf ft).

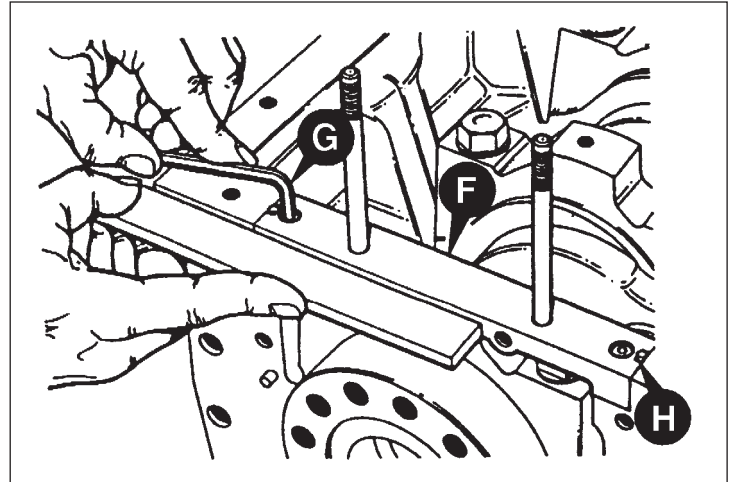
Lubrication oil leakage from the bridge piece **F** can be identified in two ways; oil may be seen around the sump rear face or oil will be evident inside the flywheel housing. There are two possible causes for leakage from the bridge piece, misalignment and/or lack of sealant.

- 3.1 Remove the flywheel using guide studs (remove two diametrically opposite bolts and temporarily fit guide studs).
- 3.2 Remove the starter motor.
- 3.3 Remove the flywheel housing (it may be necessary to tap the housing using a soft hammer to disengage the housing dowels).
- 3.4 Remove the rear seal housing as described in the section titled 'REAR OIL SEAL HOUSING'.
- 3.5 Remove the lubrication oil sump.

- 3.6 Release the two securing capscrews **G** in the bridge piece remove the bridge piece and old sealant from all faces. Loosely refit the bridge piece and align the face of the bridge piece to the rear block face using a straight edge as shown. Alignment to be within 0.05 mm (0.002 in). Tighten the securing cap screws to 9 Nm (6 lbf ft).
- 3.7 Apply Loctite 574 Multigasket to bridge piece end slots **H** using applicator gun until sealant can be seen coming from the chamfered edges of the bridge piece contact face with the cylinder block.
- 3.8 Refit flywheel housing and torque securing screws M10 to 44 Nm (33 lbf ft) and M12 to 75 Nm (55 lbf ft).
- 3.9 Refit flywheel using guide studs and torque retaining bolts to 105 Nm (77 lbf ft).

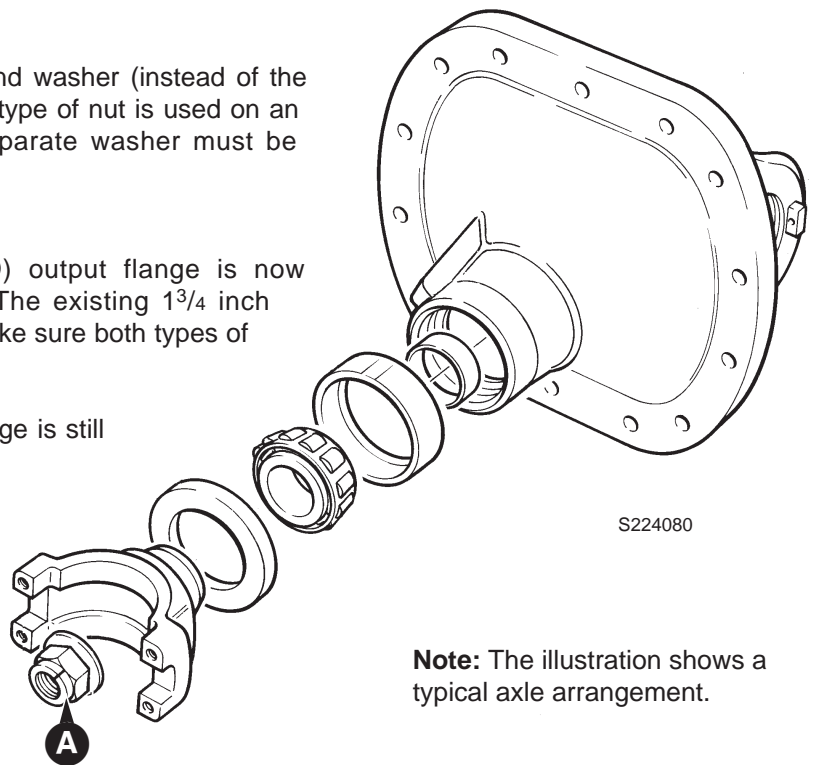
The axle flanges and transmission output flanges are now hardened (at the sealing area). The hardened flanges prevent possible oil leaks and loss of bearing pre-load by reducing the risk of fretting and subsequent loosening of the flanges.

In the event of a flange becoming loose or wearing, a new hardened type flange and new seal should be fitted. Apply a small bead of Loctite 936 around the shaft spline. Full details for removing and replacing output flanges are given in the relevant Workshop Manual.

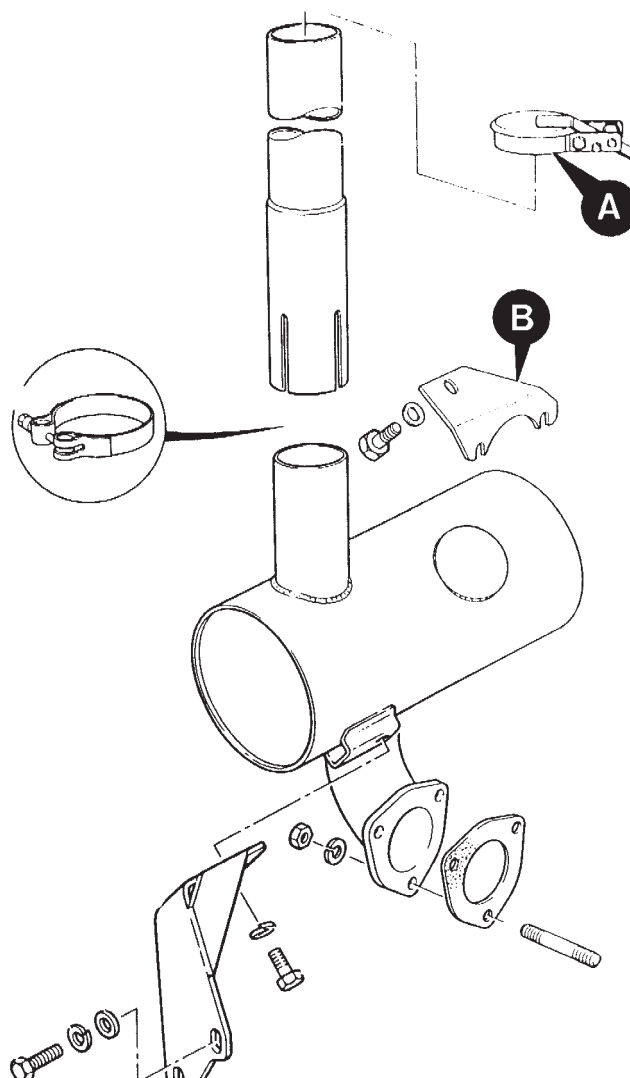
- a A secondary support bracket **B** is fitted to silencers installed on naturally aspirated engines, this will reduce failures caused by vibration. The bracket is bolted to the silencer and mounted on the exhaust manifold studs.
- b The gauge has been increased from 1.6mm to 2.0mm.
