GENERAL T.I. BULLETIN INDEX

Number	Gn001
(JCB Gen 003)	
Issue	1
Date	March 1990

SUBJECT: Tappet Adjustment

PRODUCTS AFFECTED: All Perkins 1000 series Engines

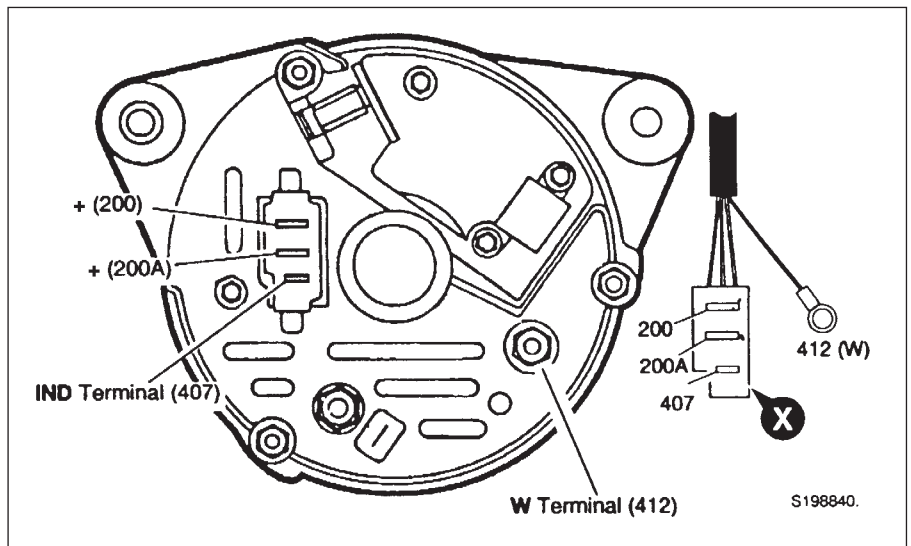
FIG 1

Two types of alternator connectors have been supplied. The alternator 'euro plug' connector (item X - FIG 1) is no longer supplied. Instead, a ring terminal and lucar connector (item Y - FIG 2) are now supplied.

If the harness has a 'euro plug' connector (item X) fitted, install the harness as shown in FIG 1. If the harness has a ring terminal and lucar connector (item Y) fitted, install the harness as shown in FIG 2.

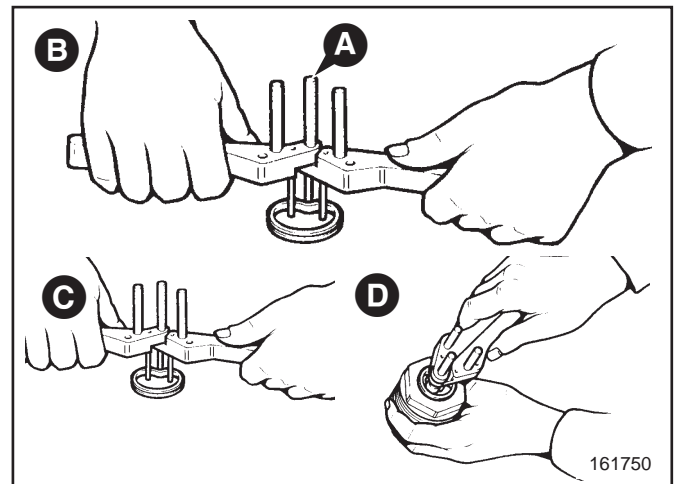
- 1 Open the tool as shown at **B** and insert the new rod seal, the seal must be fitted behind the two front pins but in front of the rear pin as shown.

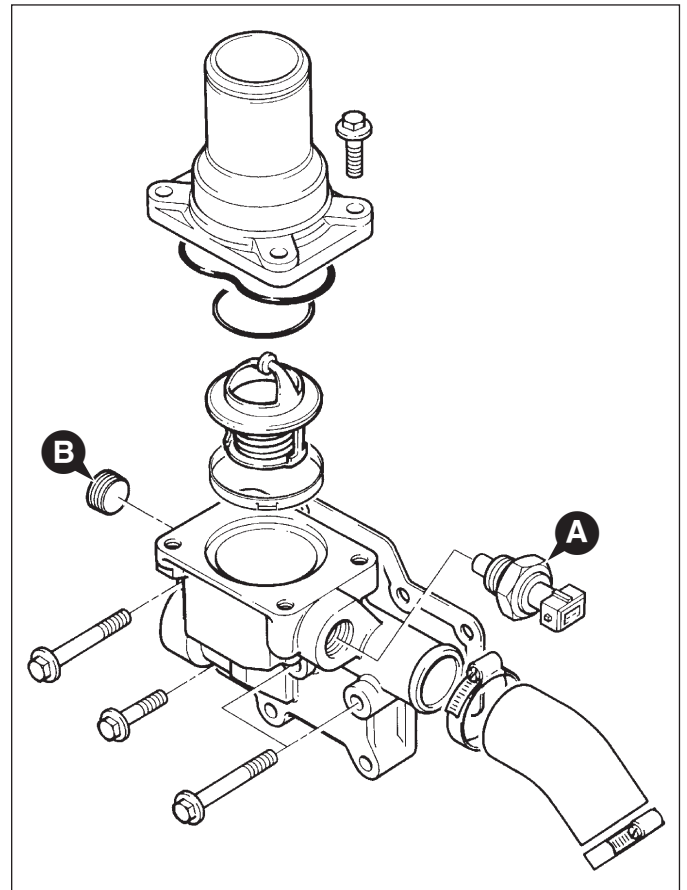
Plastic thermostat housings, fitted to some engines, will be damaged if temperature senders or blanking plugs are overtightened.

Item	Nm	kgf m	lbf ft
A - Sender (aluminium)	16	12	12
A - Sender (brass)	24	2.4	18
B - 1/2 inch Plug (metal or plastic)	4	0.4	3
B - 3/4 inch Plug (metal or plastic)	4	0.4	3

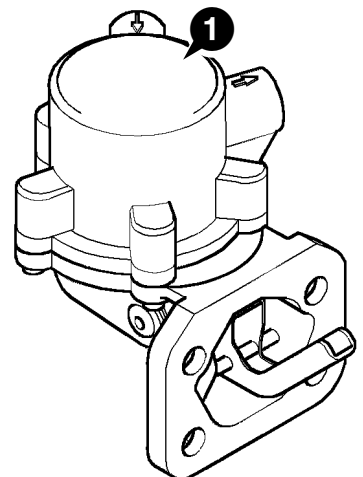
IMPORTANT: The fuel strainer can be damaged and fuel flow can be restricted if the fuel pipe is inserted too far into the inlet connection. This should be checked if a fuel restriction is suspected.

- 1 Allow the engine to cool. Remove the fuel filler cap to vent the system and reduce loss of fuel. Disconnect the fuel inlet pipe to the lift pump.
- 2 Unscrew the fuel filter **A**. Remove strainer **2** and O-ring **3**.
- 3 Clean the strainer in clean diesel fluid and dry with low pressure compressed air. Renew the strainer and O-ring if damaged.
- 4 Fit the strainer into the fuel inlet connection. Fit the fuel filter **A** and tighten to 20Nm (15 lbf ft). Fit the fuel inlet pipe carefully to prevent damage to the strainer, and tighten the union nut.

Make sure the olive on the fuel inlet pipe is in good condition and forms an effective seal. Renew the olive or pipe if necessary to prevent air entering the fuel system.

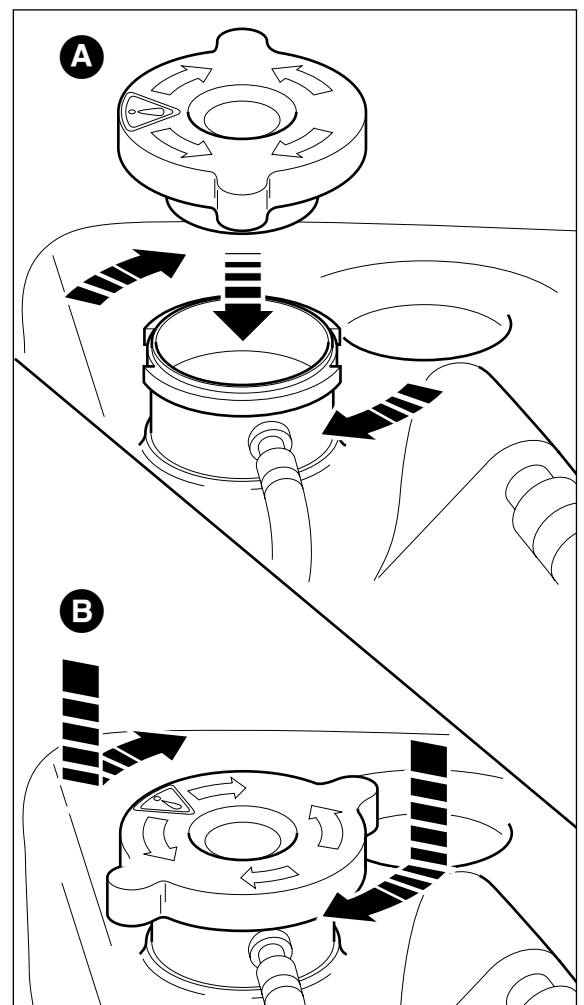
Some instances of overheating have been reported which were caused by the engine coolant filler cap not being correctly fitted. This results in the coolant system failing to pressurise, so reducing its efficiency.

When fitting the filler cap, ensure that the cap is correctly fitted. Fit and turn the cap to the first notch, as shown at **A**, then **PRESS DOWN** and continue turning **FULLY** clockwise, as shown at **B**, until the end stop is met. Failure to do this will result in inefficient cooling and may result in injury when the cap is removed.
